# RAILTRO'S HBD/HWD

## HOT BOX AND HOT WHEEL DETECTION SYSTEM WITH MULTI BEAM TECHNOLOGY

# Intelligent Rolling Stock Monitoring

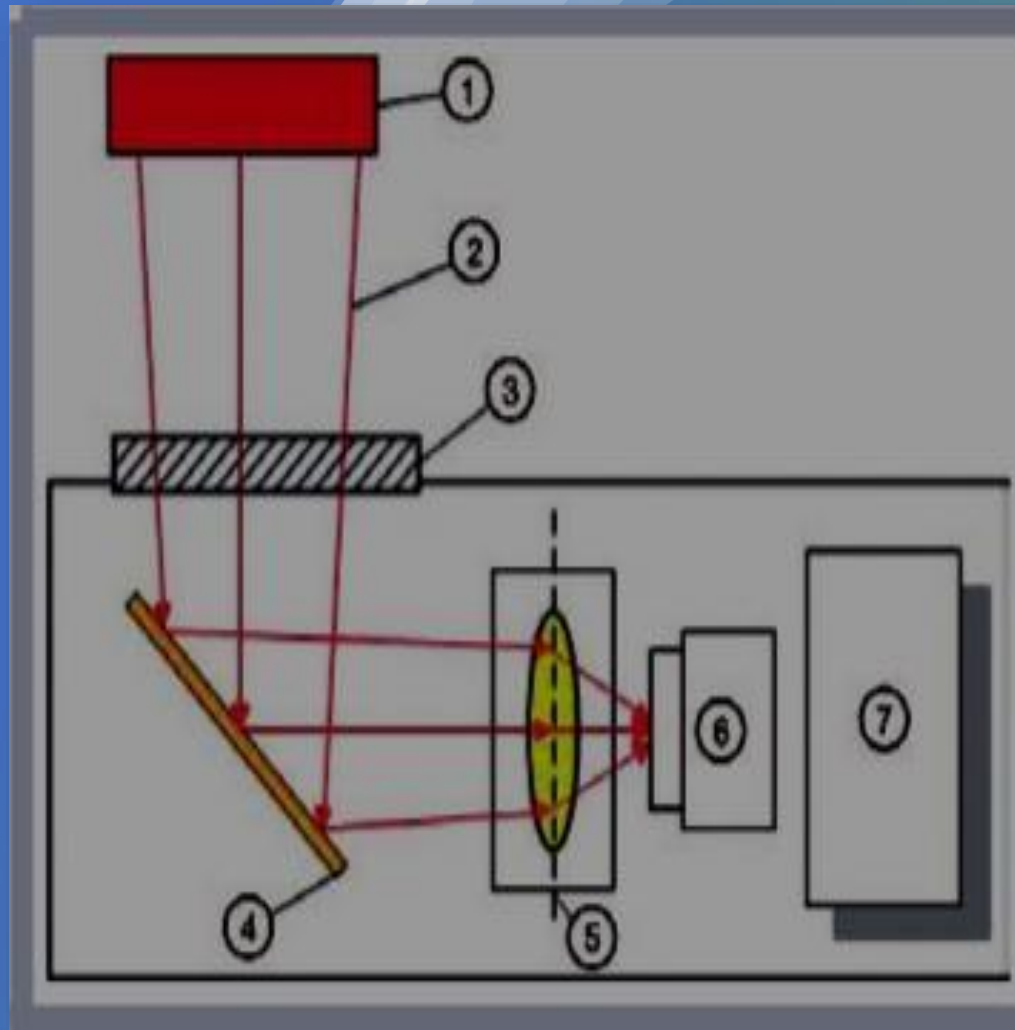
In order to be able to contactless and very quickly measure temperatures in the range from  $0^{\circ}\text{C}$  to  $650^{\circ}\text{C}$  special infrared detectors are used (quantum detectors), which convert the thermal radiation of the target into electric signals especially in the infrared range.

Like a photo-camera the measuring systems consist of lenses, mirrors and infrared detectors.

- (1) Heat target such as axle bearing, wheel, brake disk
- (2) Thermal radiation
- (3) Shutter
- (4) Deflection mirror
- (5) Optical system
- (6) Infrared sensor
- (7) Electronics

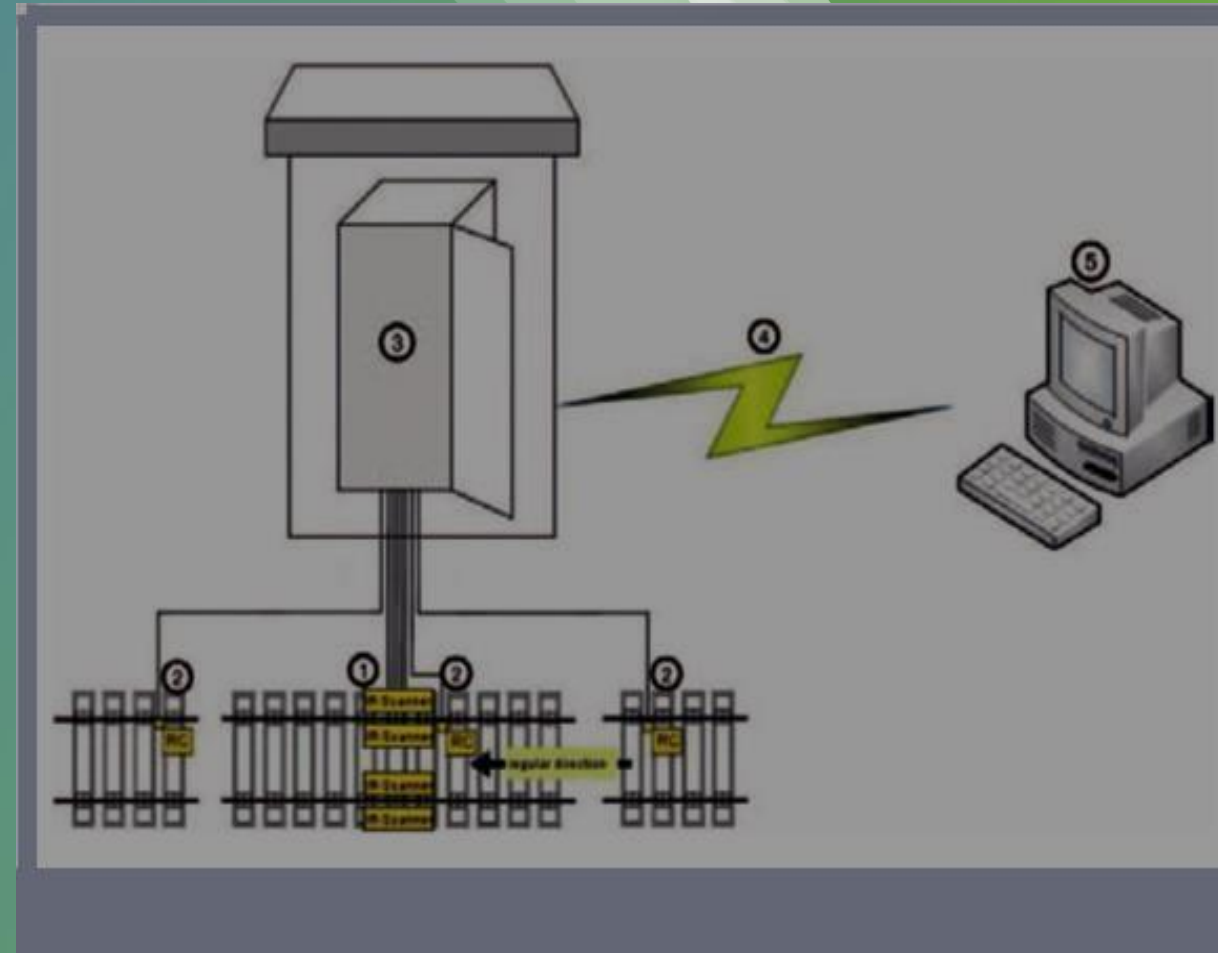
The essential structure of a HBD/HWD detector is shown schematically and it consists of the following function blocks:

- (1) Infrared measuring systems (pyrometers) in the track (in a sleeper or on the rail)
- (2) Rail contact on the track (axle counter)
- (3) Evaluation electronics near the track
- (4) Data transmission and network
- (5) Display unit at the dispatcher's work-place.

If a train approaches the measuring system, a rail contact (2) passed over activates the system and it becomes ready for measuring.

When the wheel passes the infrared measuring system (1) and the axle counters located there, the temperature values of the left - hand and the right-hand axle box cases, the temperatures of the wheel and of the brake disc (depending on the system con-figuration) are recorded and allocated to the axle number in the train consist. In the case of a dangerously high temperature, an alarm is triggered and the dispatcher (5) receives the following information at least:

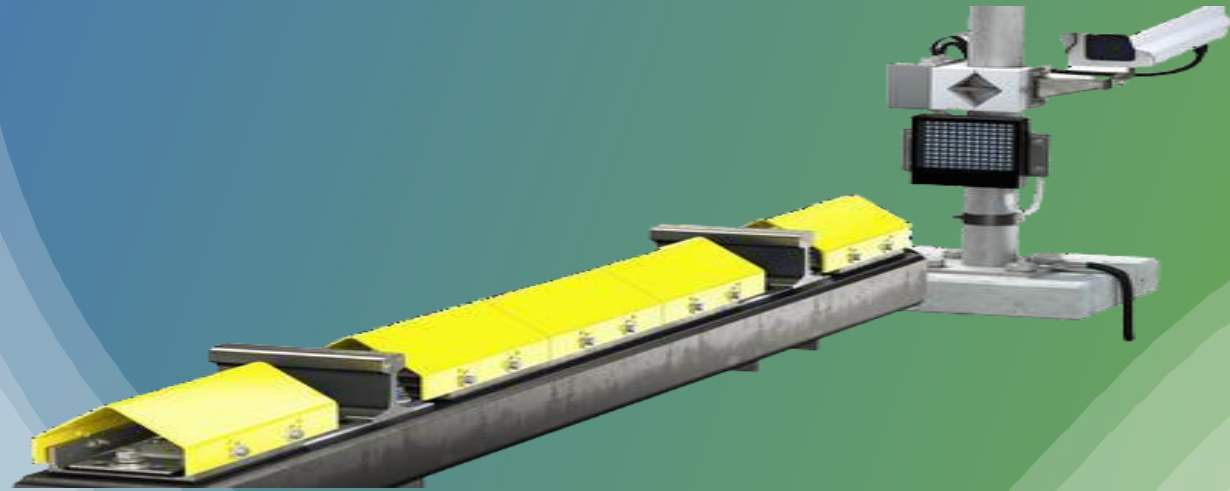
Dragging Equipment Detection using accelerometer with camera
